**Flood Control Project Maintenance  
Levee Inspections**

**Maintenance Issue Types Only, Levee Inspection Report By Mile - Fall 2015**

**Reclamation District No. 2094 Wathal**

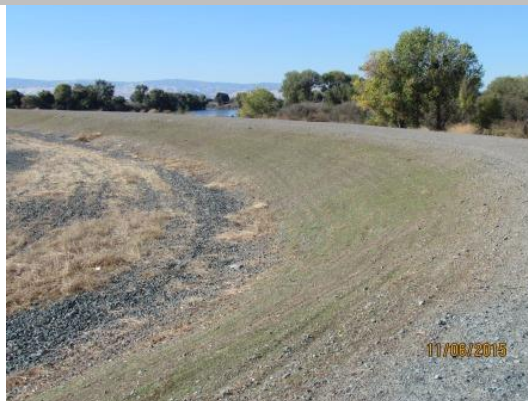
Photo 1 of 1 : FA\_2015\_RD2094\_320\_6\_20151112\_00005.jpg

LM Start	0.08	Rating **	A	Issue No.	6
LM End	2.78	Issue Type +	Ma	Location *	LS
Category	Earthen Levee			GPS Latitude/Longitude	
				Start	End
Item	Vegetation			37.771687 °	37.749548 °
				-121.299846 °	-121.288919 °
DWR ID	DWR_RD2094_01_f _ 2015_6				
Action/Comments					
Control annual grass and weeds on the levee slopes and easements.

View of the acceptable vegetation control on the landside levee slope.

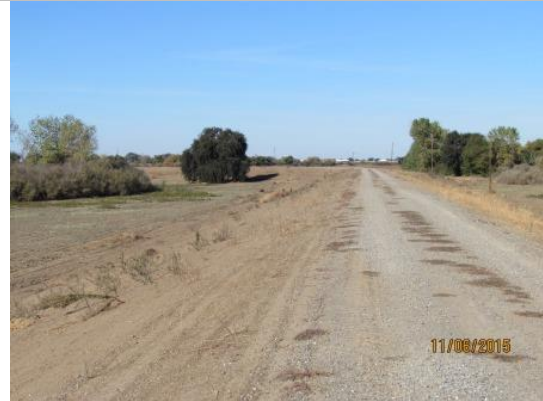
Photo 1 of 1 : FA\_2015\_RD2094\_321\_1\_20151112\_00001.jpg

LM Start	0.02	Rating **	A	Issue No.	1
LM End	0.43	Issue Type +	Ma	Location *	WS
Category	Earthen Levee			GPS Latitude/Longitude	
				Start	End
Item	Vegetation			37.759324 °	37.760603 °
				-121.299892 °	-121.306912 °
DWR ID	DWR_RD2094_02_f _ 2015_1				
Action/Comments					
Control annual grass and weeds on the levee slopes and easements.

View of the acceptable vegetation control on the waterside levee slope.
